Chapter-IV

Monitoring and Maintenance of Projects and Coordination among Stakeholders

Monitoring of irrigation projects

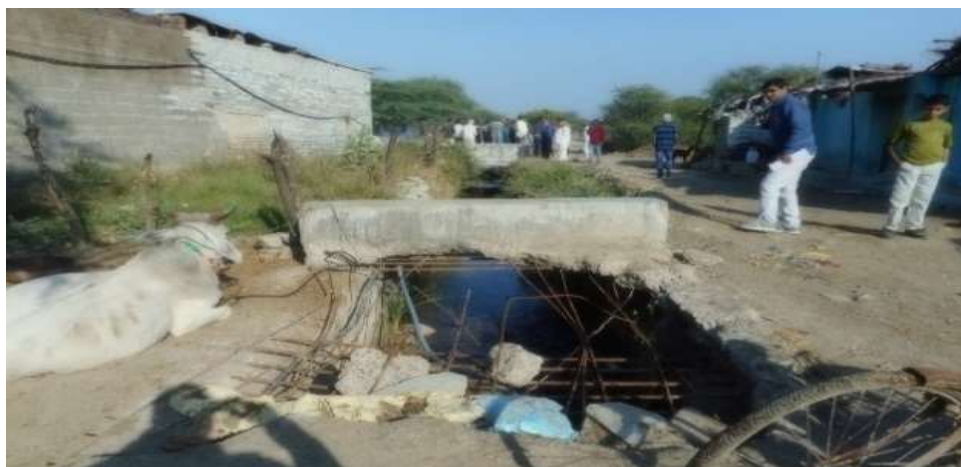
LMC Piplad Project near Amlı Kurd village

(i) In Piplad, Mamtori and Ghat Pick Up Weir, canals were in damaged position at some places. In Mamtori, the broken portion was being used as a path.

State Government stated (March 2021) that canal has not been running due to non-availability of water in tank since long time.

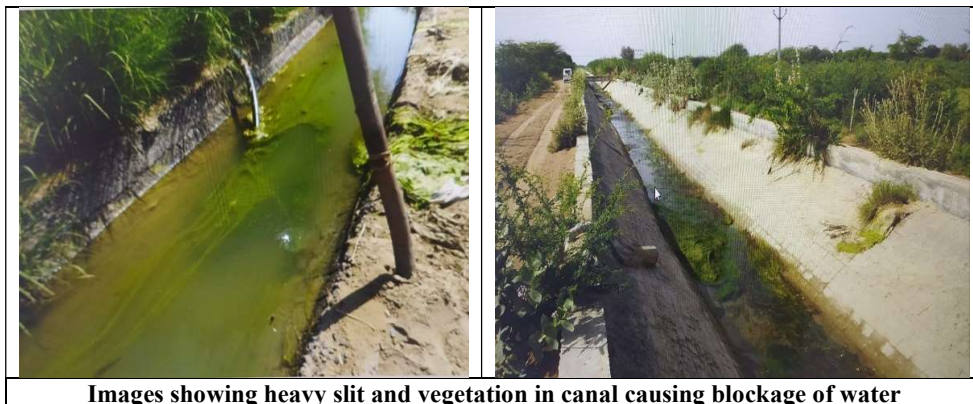
(ii) In NCP some *diggies* e.g. Sukdi Minor (11 *diggies*) were not operational. Similarly, in Akoda Minor (11 *diggies*) and Dhingpura Minor (14 *diggies*) neither the electric pumps were installed nor electric connections were taken. Moreover, the farmers were taking water directly from canal by using their own pumps in unauthorized way as farmers have also taken unauthorized electric connections. There was heavy silt deposited and

vegetation and algae grown in canal causing blockage/decreased flow velocity of water through canal and hence the water could not reach to the tail end.

State Government stated (March 2021) that the work of removal of silt, etc. is carried out by WUAs from time to time, particularly before start of Rabi season. Reply is not tenable as heavy silt deposition, vegetation and algae were found during joint physical inspection.

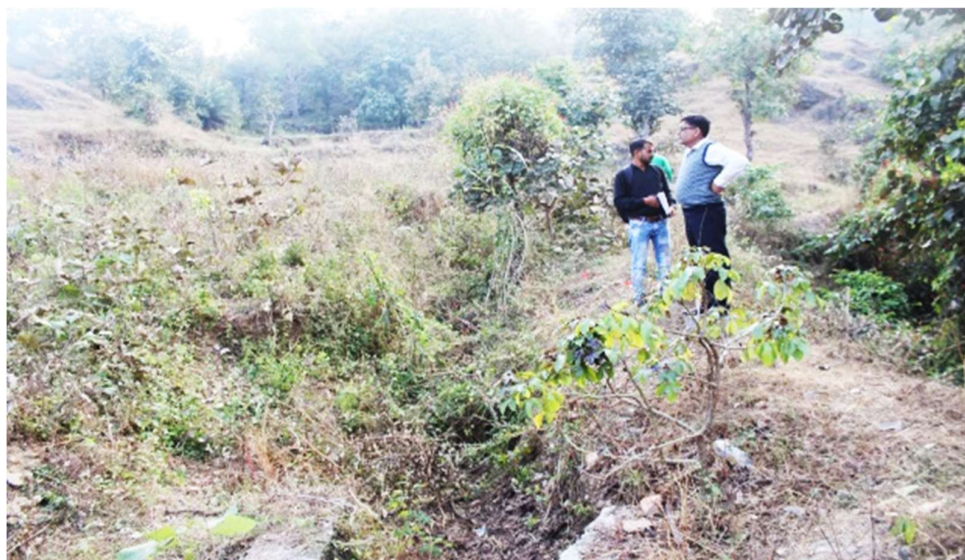
Vegetation/silting in the Do Nadi canal

(iii) In Do Nadi, it was seen during physical verification that there were seepages in dam and accumulation of silt and vegetation in some reaches of canal, causing loss of water flow.

State Government stated (March 2021) that seepages in dam sluice well have been repaired. Jungle and silt clearance had been done before Rabi crop. Reply is not tenable as department had not made available any evidence in this regard.

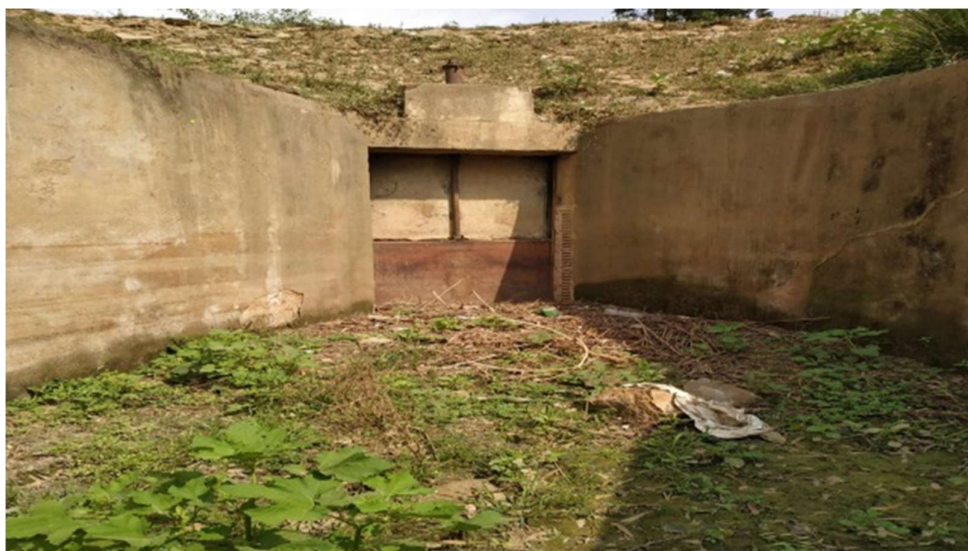
Head sluice at Ghat Pick Up Weir

(iv) During joint physical inspection, it was found that the Head sluice of the Ghat Pick Up Weir was not in working position as gate of sluice was jammed due to heavy deposition of silt (almost one feet).
